Rejuvenators, Rejuvenator/Sealers, and Seal Coats for Airfield Pavements

James E. Shoenberger

February 2003

Final report

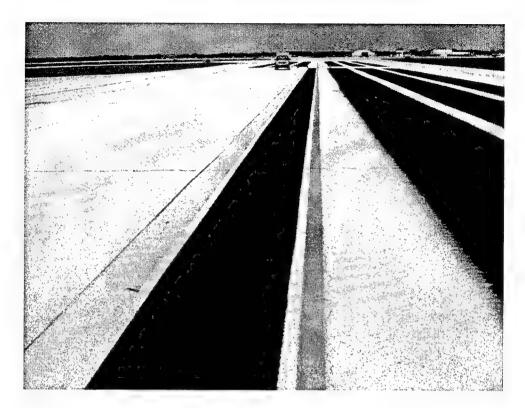
One area of visual difference that could be noted was the overall color or amount of material left on the pavement surface. Within a few months it was almost impossible to detect the location of the Reclamite test strips on the pavement. The APR-100 material also lightened considerably but was still very visible. On the whole, the petroleum-based materials all lightened more than the coal-tar materials.

Figure 10. View of Antiskid material to left of the taxiway center line. Note: 7 months after placement, Reclamite (placed to left of the Antiskid) is barely visible
